Analysis of a Clinically Failed, Mechanically Intact, Reconstructive Compression Plate

A reconstructive orthopedic bone plate was submitted for analysis. Traditional failure analysis methods were used to assess the mode of the plate failure. Metallographic investigation of the plate was carried out in this report. Since limited data was available in the literature and clinical data related to subject demography, date of removal as well as reasons for removal unknown, in depth analysis was not possible. However, the plate was received in in-tact condition with minor biological deposits and scratches, it is speculated that the failure of the plate may have been due to biological/clinical reasons, likely infection, rejecting the device due to lack of union at the fracture site.

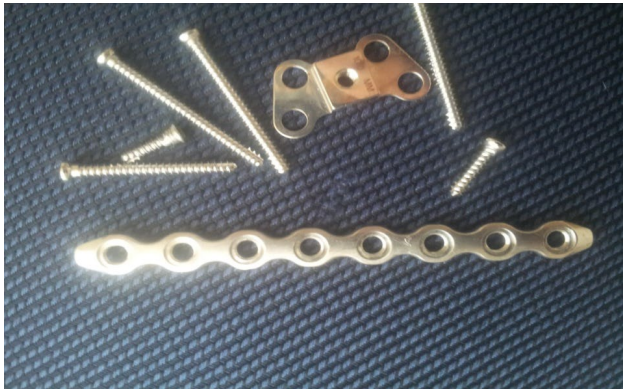
Figure 1: Reconstructive locking plate

The submitted reconstructive plate was a 8 hole, 105.5 mm long, 2.8mm thick along with 2 locking head screws (4.3 mm diameter and 14 mm long) and 4 non-locking screws (4.3 mm diameter and 37 mm long) were submitted for the failure analysis. Both plates and locking head screws are made per specification ASTM 240 and ASTM 666 [6]. The plate was labeled properly with a serial number (Figure 1). Even though the subject demography, implant site, date of removal and reason for removal was unknown, the analysis of the plate was carried out with visual, optical, and scanning electron microscopes and surface topography mapped.

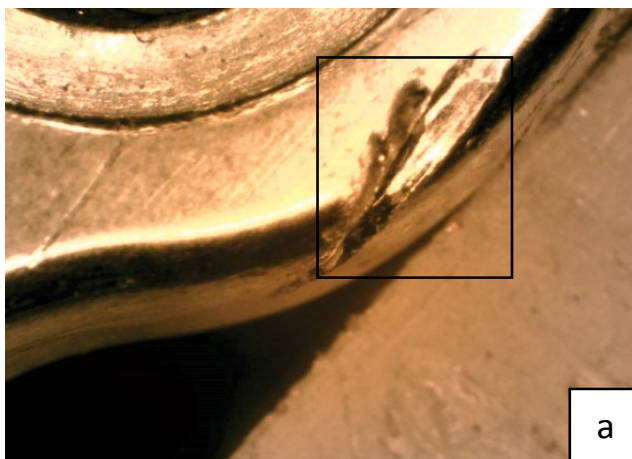
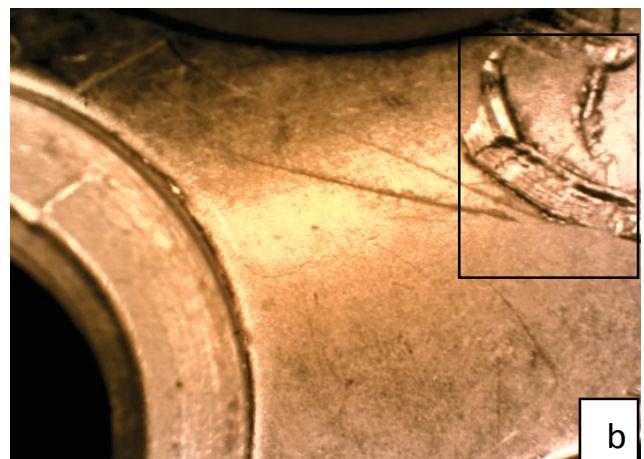
Figure 2a and 2b: Marked surface of the plate with scratches and pits (mag: 10X)

The plate contained scratch marks as well as some corrosion and debris on the surface and holes see Figure 2 and Figure 3.

The plate was received in the intact form. Since the plate was used in vivo some damage due to exposure was documented in this paper in the form of corrosion pits, debris (biological in nature) and scratches, though it is unknown whether those scratches occurred during exposure, removal or transportation and storing of the device. The material has met the specification requirements and thus was a successful design per engineering considerations.
