Functional Complexity Failures and Automation Surprises: the Mysterious Case of Controlled Flight into Stall (CFIS)

FUNCTIONAL COMPLEXITY FAILURES AND AUTOMATION SURPRISES: THE MYSTERIOUS CASE OF CONTROLLED FLIGHT INTO STALL (CFIS)

Nineteen modern airliner Loss of Control (LOC) accidents resulting in aerodynamic stalls were analyzed. These accidents involved structurally and mechanically sound aircraft decelerating through the $1.3V_{\text{Stall}}$ buffer to the stall airspeed - i.e. a Controlled Flight into Stall (CFIS). The analysis produced three main observations: First, the accidents were “functional complexity” failures -- the result of a complex sequence of behaviors of the automation functions. There were no consistent: failures that triggered the events (e.g. sensor failures), effects of triggering events on the automation (e.g. mode change), or commands issued by the automation (e.g. thrust setting). Second, the pilots were unable to intervene effectively due to the absence on the flight deck of relevant information and salient cues to monitor these rare events or their effects. Third, there was no single intervention that could mitigate all of these accidents. Implicat

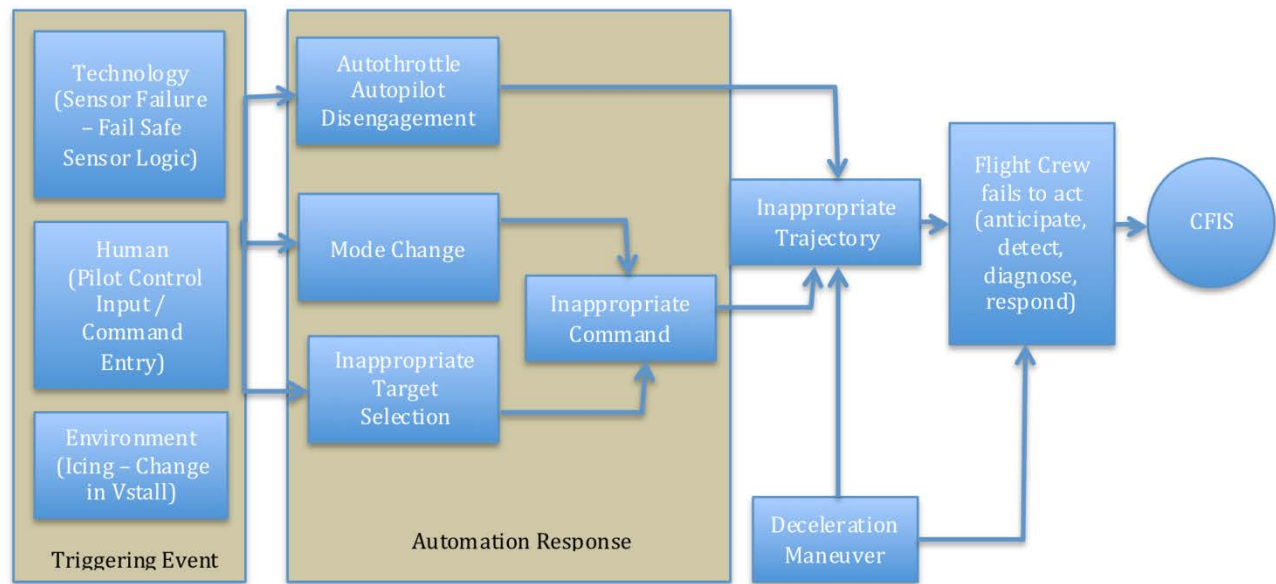
Figure 1. Sequence of Events Leading to Controlled Flight Into Stall (CFIS)

Nineteen accidents were reviewed. A list and summary of the accidents and their characteristics is included in Sherry et al (2014). All 19 accidents and incidents can be described by the sequence of events presented in Figure 1: A *triggering event* (e.g. sensor failure) has an *effect on the automation* (e.g. mode change). This leads to an *inappropriate command* for pitch or thrust. The inappropriate command occurs while the aircraft is experiencing a relative *deceleration* to the minimum safe operating speed. The relative deceleration is the result of either the aircraft decelerating to a fixed minimum safe operating speed or a change in the minimum safe operating speed (e.g. due to ice contamination on the wing). Finally, the flight crew *fails to intervene* to arrest the deceleration through the minimum safe operating speed and into controlled flight into a stall (CFIS).
